**Flood Control Project Maintenance
Levee Inspections**

Fall 2018 Levee Maintenance Deficiency Summary Report

San Joaquin River Basin

Reclamation District No. 2063 Crows Landing

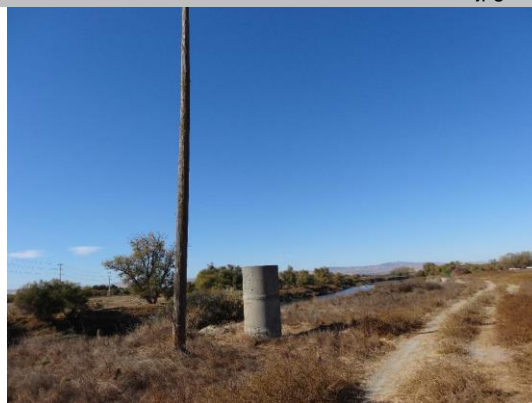
Photo 1 of 3 : UCIP_FA_2018_50216_43166.jpg

11/05/2013:- Pipe has visible holes throughout both LS and WS along with pipe deformation. - looks abandoned. Needs proper abandonment.- alfalfa valve on concrete pipe riser on waterside toe.- no slide gate found on waterside. No pump and pile structure found in river.

FIELD_STRUCT_DESC: *ABANDONED* 24-inch corrugated metal irrigation discharge pipe through the levee, 10 feet below the crown, not found during 2016 inspection. Slide gate in a corrugated metal pipe (CMP) riser on the waterside (WS) slope, not found during 2016 inspection. Pipe supported on two timber pile bents across a drainage ditch on the landside (LS), only pile remnants found during 2016 inspection. Pump on a pile structure in the river, not found during 2016 inspection. Two concrete standpipes on the WS berm, one of which was found during the 2016 inspection. Installed by USACE in 1961.

WS view: abandoned concrete standpipe and abandoned power pole.

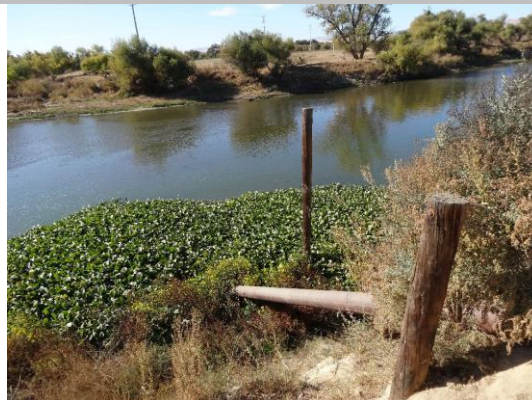
Photo 2 of 3 : UCIP_FA_2018_50216_43161.jpg

WS view: steel pipe immersed into the river. No pump found.

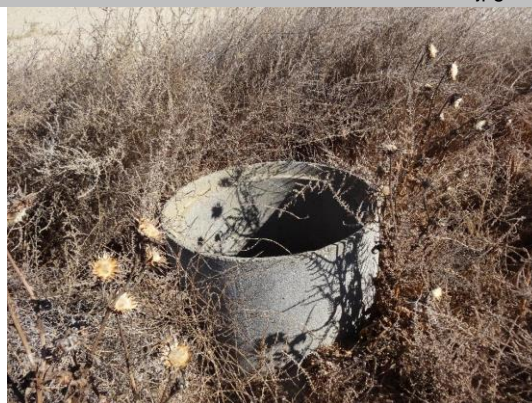
Photo 3 of 3 : UCIP_FA_2018_50216_43160.jpg

Comment Code						
Inspector Comment						
FS_ID:50216 DS_ID:22075 EP_NO: N/A Repair Type: Non-Urgent Crossing Status: Indicator Found UCIP Comments: 08/23/2016: Could not locate pipe during inspection, though it was very prominently visible on the WS bank and LS ditch as per 2013 photos. I confirmed with RD2063 president Joe Sallaberry that the pipe was filled with concrete through the levee but removed at the LS ditch. Could not locate pipe's ends during inspection. No permit exists for this work. Crossing has been downgraded from Urgent to Non-Urgent since we lack documentation verifying proper abandonment. 11/05/2013:- Pipe has visible holes throughout both LS and WS along with pipe deformation. - looks abandoned. Needs proper abandonment.- alfalfa valve on concrete pipe riser on waterside toe.- no slide gate found on waterside. No pump and pile structure found in river. FIELD_STRUCT_DESC: *ABANDONED* 24-inch corrugated metal irrigation discharge pipe through the levee, 10 feet below the crown, not found during 2016 inspection. Slide gate in a corrugated metal pipe (CMP) riser on the waterside (WS) slope, not found during 2016 inspection. Pipe supported on two timber pile bents across a drainage ditch on the landside (LS), only pile remnants found during 2016 inspection. Pump on a pile structure in the river, not found during 2016 inspection. Two concrete standpipes on the WS berm, one of which was found during the 2016 inspection. Installed by USACE in 1961. [Additional Reference(s): DWR Levee Log, 1992. USACE San Joaquin O&M Manual 6, September 1961, (HLM 1.29)]. FS Date: 8/23/2016

WS view: concrete riser with alfalfa valve on levee berm.

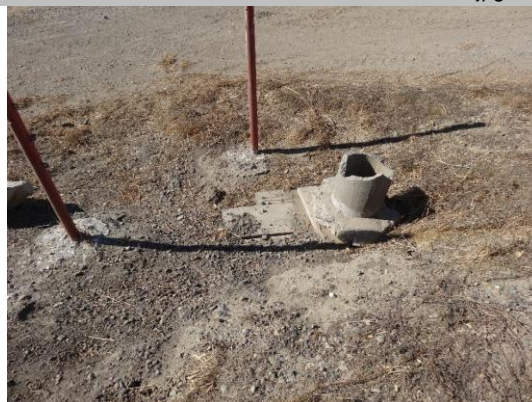
Photo 2 of 3 : UCIP_FA_2018_24404_43344.jpg

Comment Code						
Inspector Comment						
FS_ID:24404						
DS_ID:22078						
EP_NO: N/A						
Repair Type: Non-Urgent						
Crossing Status: Found						
UCIP Comments: 11/05/2013 Concrete distribution box with alfalfa valve not found at the waterward toe.Two steel standpipes and dismantled concrete standpipe on waterside levee toe.Concrete distribution box 50 ft off the levee center. (P. Amatya - DWR UCIP)						
FIELD_STRUCT_DESC: 30-inch corrugated metal irrigation discharge pipe through the levee, 16.5 feet below the crown. Slide gate in a concrete distribution box, 50 feet off the levee. Underground irrigation system. Installed by USACE in 1961. [Additional Reference(s): DWR Levee Log, 1992. USACE San Joaquin O&M Manual 6, September 1961, (HLM 2.11)].						
FS Date: 11/5/2013

WS view: a dismantled concrete pipe on levee toe.

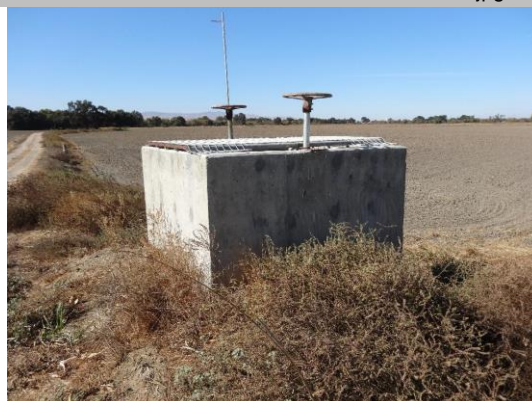
Photo 3 of 3 : UCIP_FA_2018_24404_43343.jpg

Comment Code						
Inspector Comment						
FS_ID:24404 DS_ID:22078 EP_NO: N/A Repair Type: Non-Urgent Crossing Status: Found UCIP Comments: 11/05/2013 Concrete distribution box with alfalfa valve not found at the waterward toe.Two steel standpipes and dismantled concrete standpipe on waterside levee toe.Concrete distribution box 50 ft off the levee center. (P. Amatya - DWR UCIP) FIELD_STRUCT_DESC: 30-inch corrugated metal irrigation discharge pipe through the levee, 16.5 feet below the crown. Slide gate in a concrete distribution box, 50 feet off the levee. Underground irrigation system. Installed by USACE in 1961. [Additional Reference(s): DWR Levee Log, 1992. USACE San Joaquin O&M Manual 6, September 1961, (HLM 2.11)]. FS Date: 11/5/2013

WS view: concrete distribution box with slide gate off the levee toe.

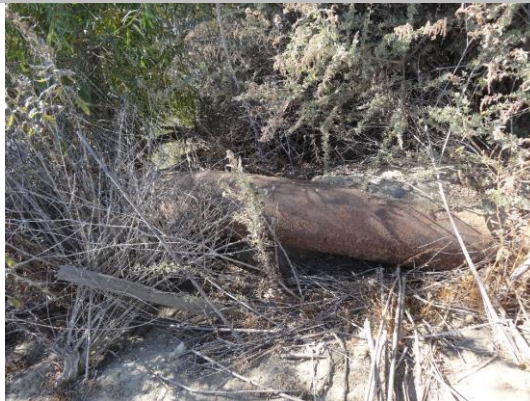
Photo 1 of 3 : UCIP_FA_2018_24427_43439.jpg

Comment Code						
Inspector Comment						
FS_ID:24427 DS_ID:22085 EP_NO: N/A Repair Type: Non-Urgent Crossing Status: Found UCIP Comments: 11/05/2013 Abandoned steel pipe and service pole on waterside. Pump not found on river bank. CMP riser on waterside slope. Slide gate not found in CMP riser. Steel pipe riser on waterside berm.Damaged PVC standpipe on waterside slope. (P. Amatya - DWR UCIP) FIELD_STRUCT_DESC: *ABANDONED* 24-inch corrugated metal irrigation discharge pipe through the levee, 10 feet below the crown. Slide gate in a corrugated metal pipe (CMP) riser on the waterside (WS) slope. 20-inch standpipe 3 feet from the landside (LS) toe. 12-inch pipe across the berm and into a CMP riser on the WS slope. Pump on riverbank. Installed by USACE in 1961. [Additional Reference(s): DWR Levee Log, 1992. USACE San Joaquin O&M Manual 6, September 1961, (HLM 2.46)]. FS Date: 11/5/2013

WS view: abandoned steel pipe on river bank. No pump found on river bank.

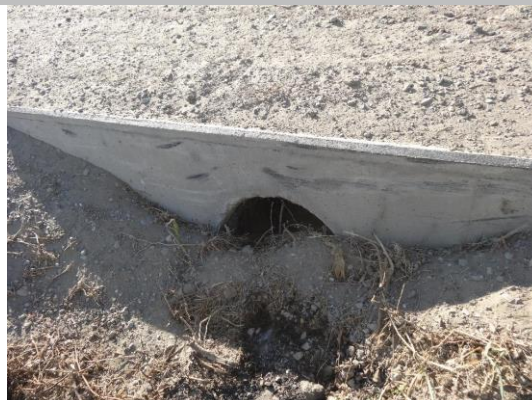
Photo 3 of 3 : UCIP_FA_2018_24443_43520.jpg

WS view: pipe, flap concrete headwall with soil debris blocking the inlet.

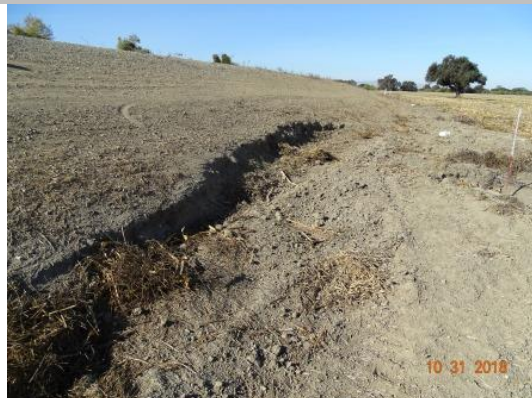
Photo 1 of 1 : FA_2018_RD2063_112_41_20181114_00126.jpg

View of agricultural equipment cutting into the levee slope. (Fall 2018)

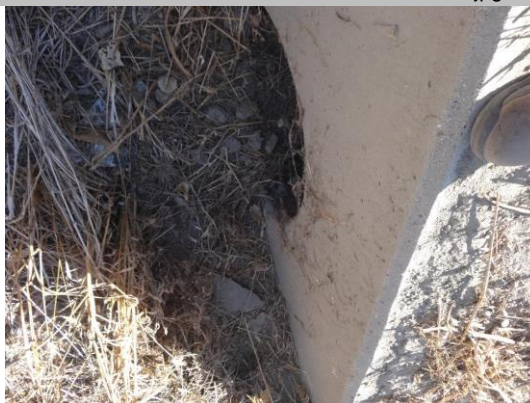
Photo 3 of 3 : UCIP_FA_2018_24469_43643.jpg

LS view: CM pipe and concrete headwall on levee slope. Debris blocking inlet pipe.

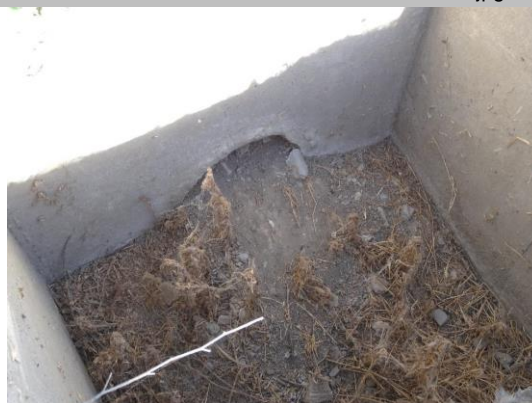
Photo 3 of 3 : UCIP_FA_2018_24485_43665.jpg

LS view: inside view of inlet box on levee toe. Debris blocking inlet pipe.

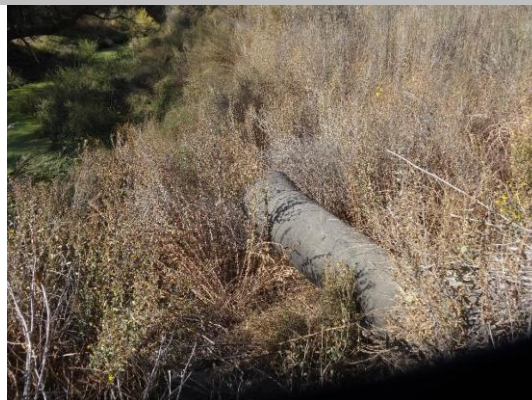
Photo 2 of 3 : UCIP_FA_2018_25025_45109.jpg

WS view: discharge pipe end on levee toe. No flap gate.

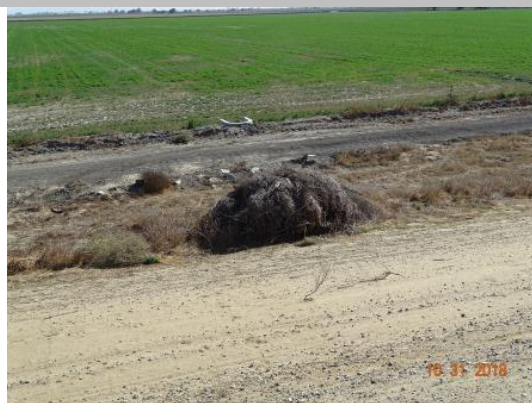
Photo 1 of 1 : FA_2018_RD2063_112_46_20181114_00127.jpg

View of pruning pile to be burned at levee toe. (Fall 2018)

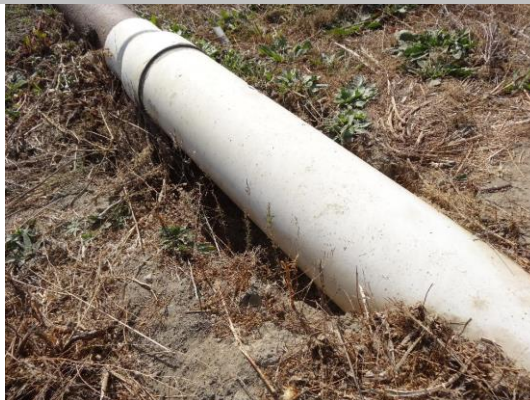
Photo 3 of 3 : UCIP_FA_2018_24628_43936.jpg

WS view: exposed pipe on levee slope. Erosion under the pipe.

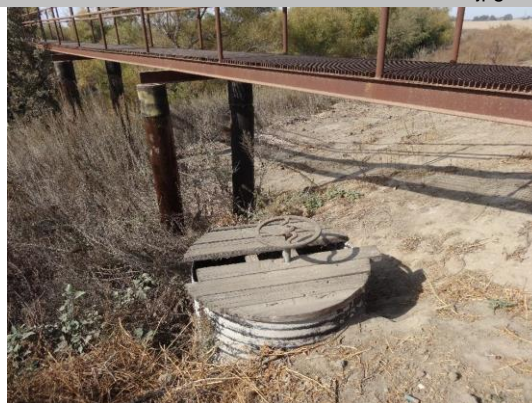
Photo 3 of 3 : UCIP_FA_2018_24629_43944.jpg

WS view: gate valve in CMP riser. Soil erosion around CMP riser.

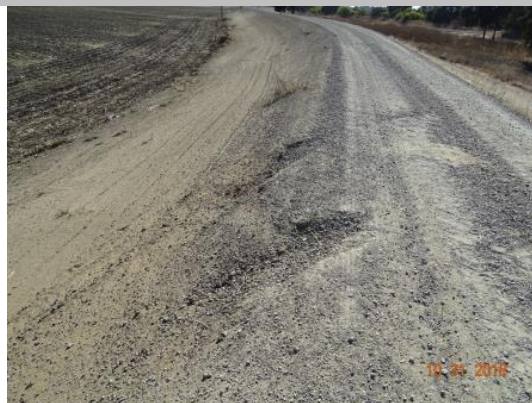
Photo 1 of 1 : FA_2018_RD2063_112_50_20181114_00130.jpg

View of vehicle damage to landside shoulder. (Fall 2018)

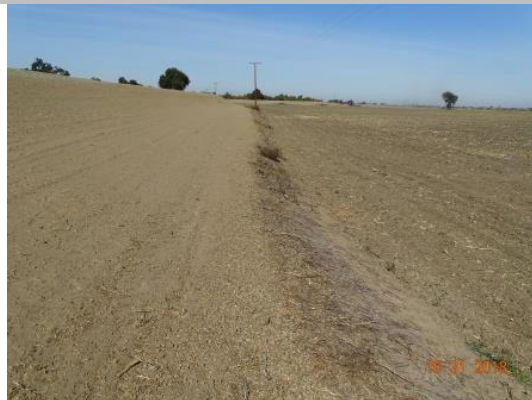
Photo 1 of 1 : FA_2018_RD2063_112_51_20181114_00131.jpg

View of cut into levee slope from agricultural equipment. (Fall 2018)

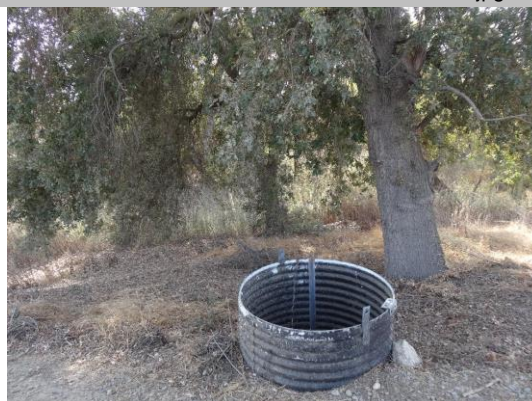
Photo 1 of 3 : UCIP_FA_2018_25031_45141.jpg

WS view: CMP riser with slide gate. Missing slide gate handwheel.

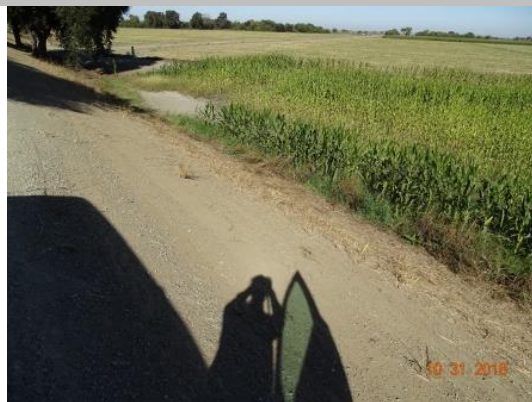
Photo 1 of 1 : FA_2018_RD2063_112_52_20181114_00132.jpg

View of corn planted in levee toe right up to the landside slope. (Fall 2018)

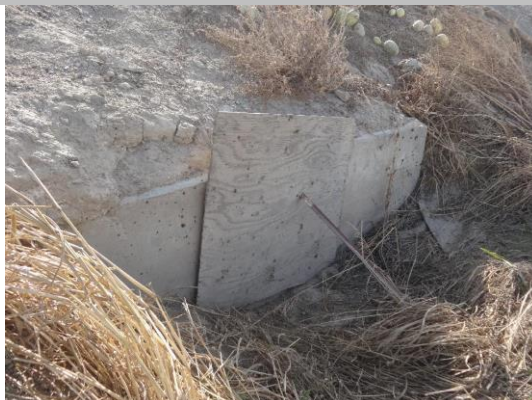
Photo 3 of 3 : UCIP_FA_2018_51825_43982.jpg

LS view: concrete headwall on levee end. Pipe opening blocked by plywood.

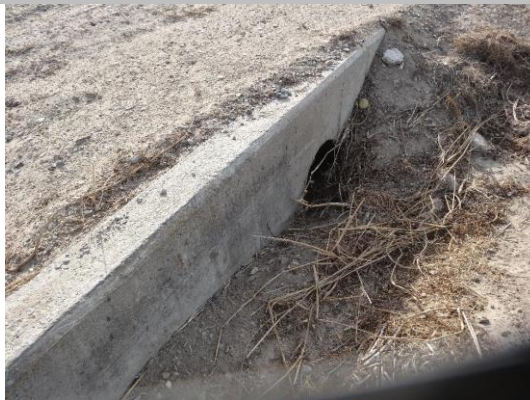
Photo 2 of 2 : UCIP_FA_2018_24645_43987.jpg

LS view: concrete headwall and partially blocked inlet opening.

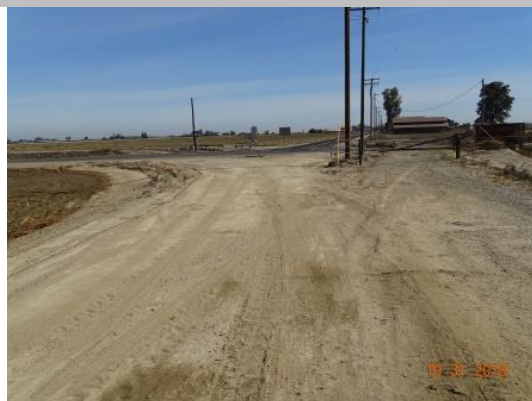
Photo 1 of 1 : FA_2018_RD2063_112_54_20181114_00133.jpg

View of unpermitted ramp coming off of street. (Fall 2018)
